BAE SYSTEMS Environmental Factual Report for Site Pollution Investigation

Site: Akko Steel Mills

Client: Enosh Systems

ORIGINATOR	CHECKED BY	AUTHORISED BY
Matthew Lennard BSc (Hons) MSc Geo-environmental Engineer	Paul Harris BSc PGDip FGS Senior Geo-environmental Engineer	Dave Taylor BEng (Hons) MSc ACSM FGS Site Assessment Manager
Project No: A249-00	Report Ref: A249-00-R2-E	Issue Date: January 2005

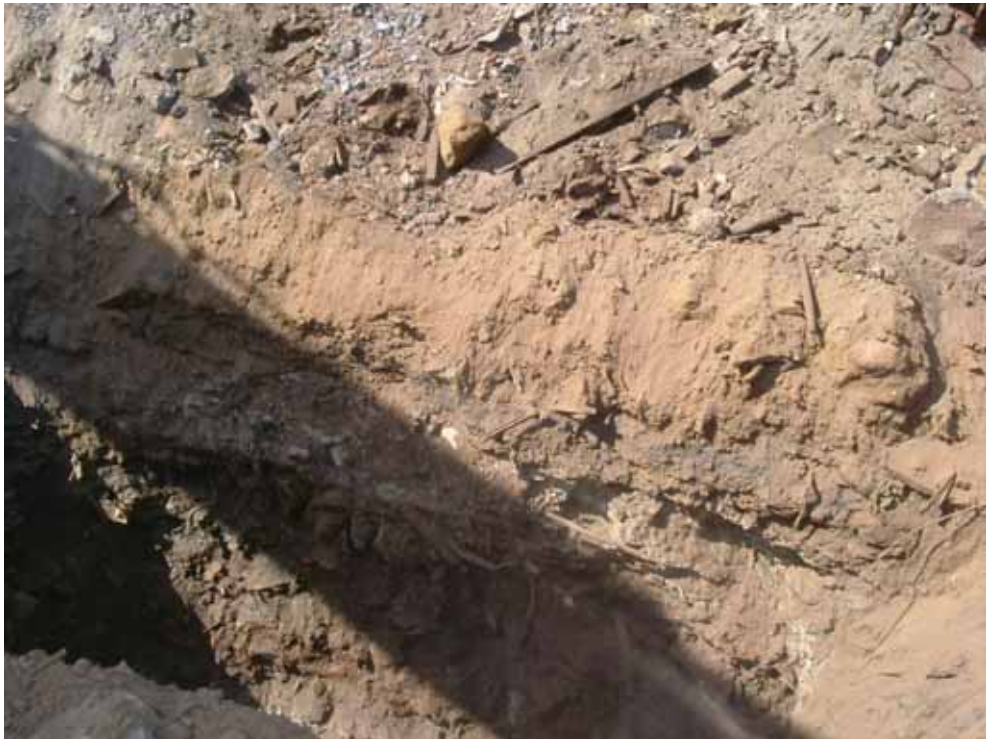
Trial Pit TP10

At TP10 on the western waste mound excavated material, understood to be filter dust, appeared to be undergoing an exothermic reaction: it was observed that the ash and clinker were hot to touch and much hotter than the surrounding material. If an exothermic reaction is occurring in the waste mound it has only minor implications for the current site use but may need further consideration for any remedial action.

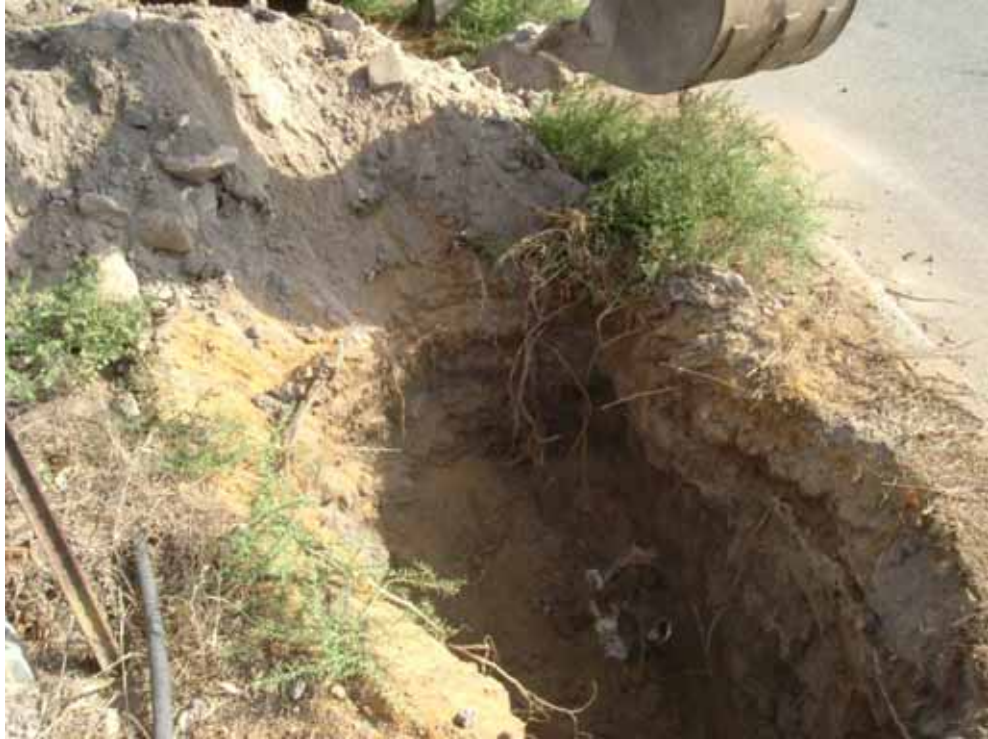
Trial Pit TP32

Remarks Abandoned due to presence of services.		
	Scale (approx) 1:50	Logged By ML	Figure No. A249-00.TP32

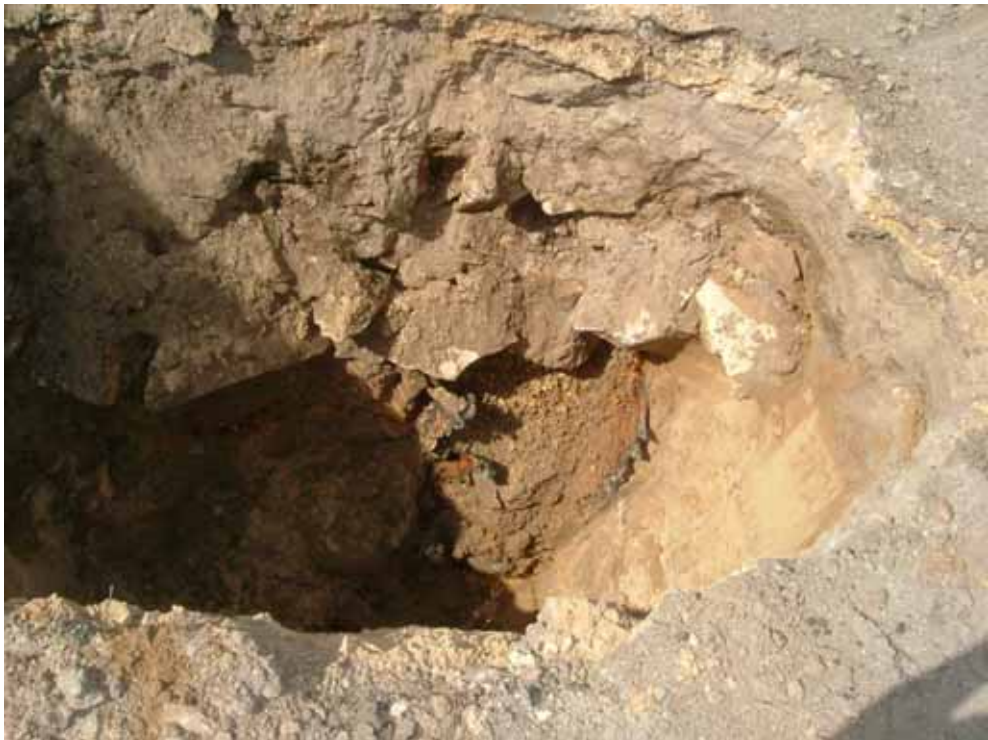
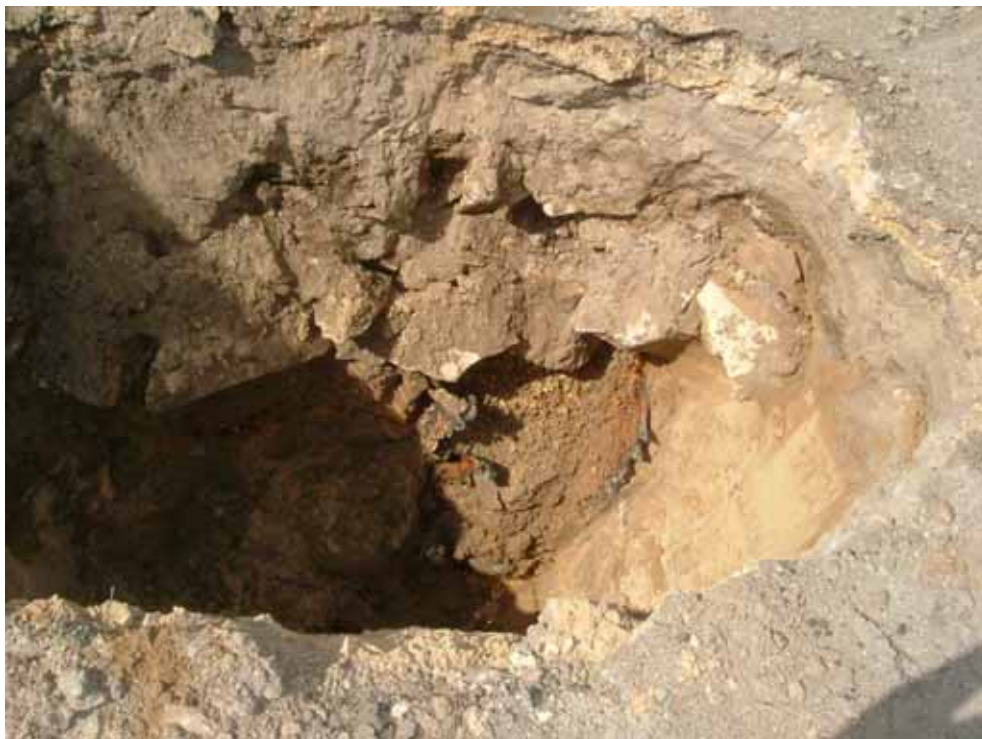
Trial Pit TP39

Plan 	Remarks Water entry at 1.9m. Hydrocarbon staining on surface					
	<table border="1"> <tr> <td>Scale (approx)</td> <td>Logged By</td> <td>Figure No.</td> </tr> <tr> <td>1:50</td> <td>ML</td> <td>A249-00.TP39</td> </tr> </table>	Scale (approx)	Logged By	Figure No.	1:50	ML
Scale (approx)	Logged By	Figure No.				
1:50	ML	A249-00.TP39

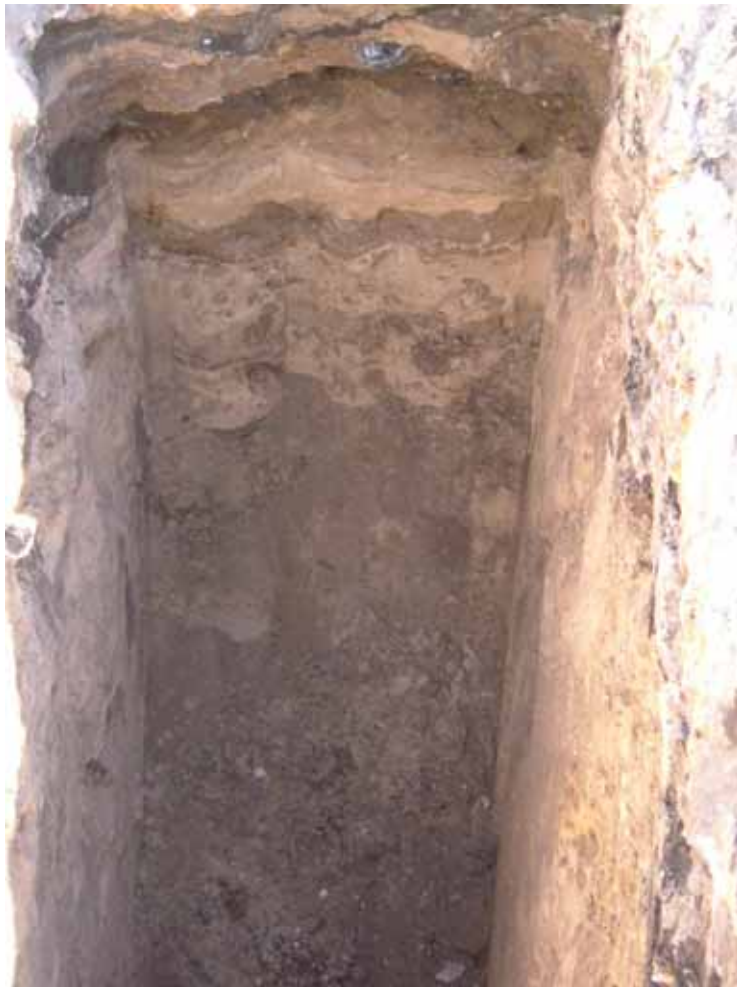
Trial Pit TP34

Plan .	Remarks Adjacent building heavily stained with hydrocarbons on wall. Water entry below 2m, TP walls collapsed below 1.4m.		
	<table border="1"> <tr> <td>Scale (approx) 1:50</td> <td>Logged By ML</td> <td>Figure No. A249-00.TP34</td> </tr> </table>	Scale (approx) 1:50	Logged By ML
Scale (approx) 1:50	Logged By ML	Figure No. A249-00.TP34

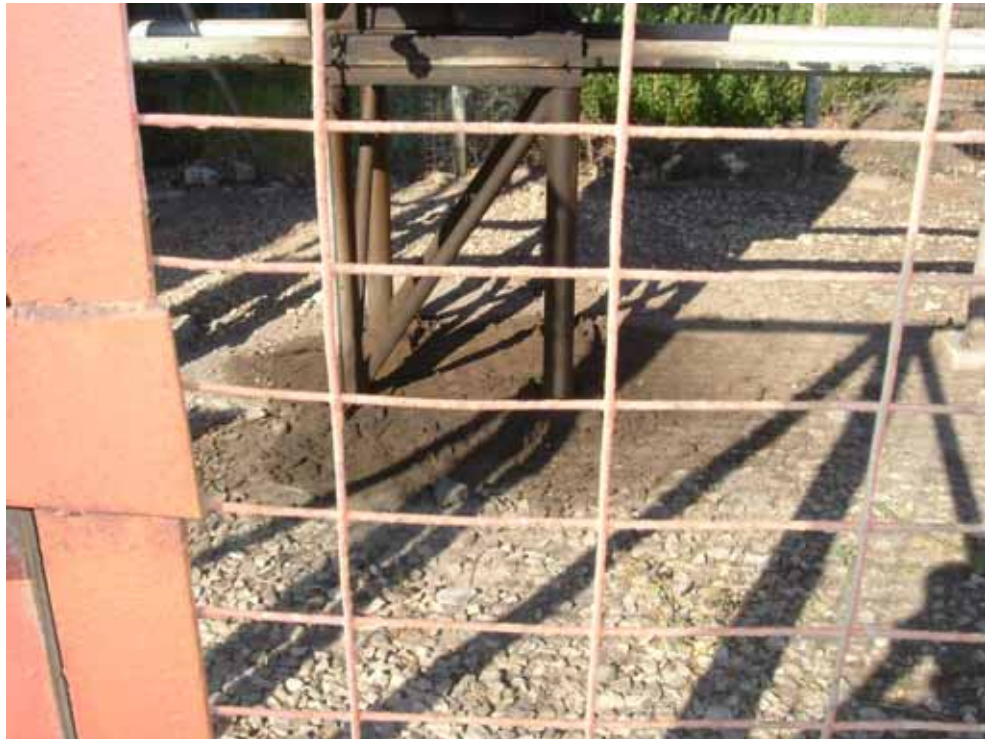
Hydrocarbon Staining Under Transformer Near to TP38

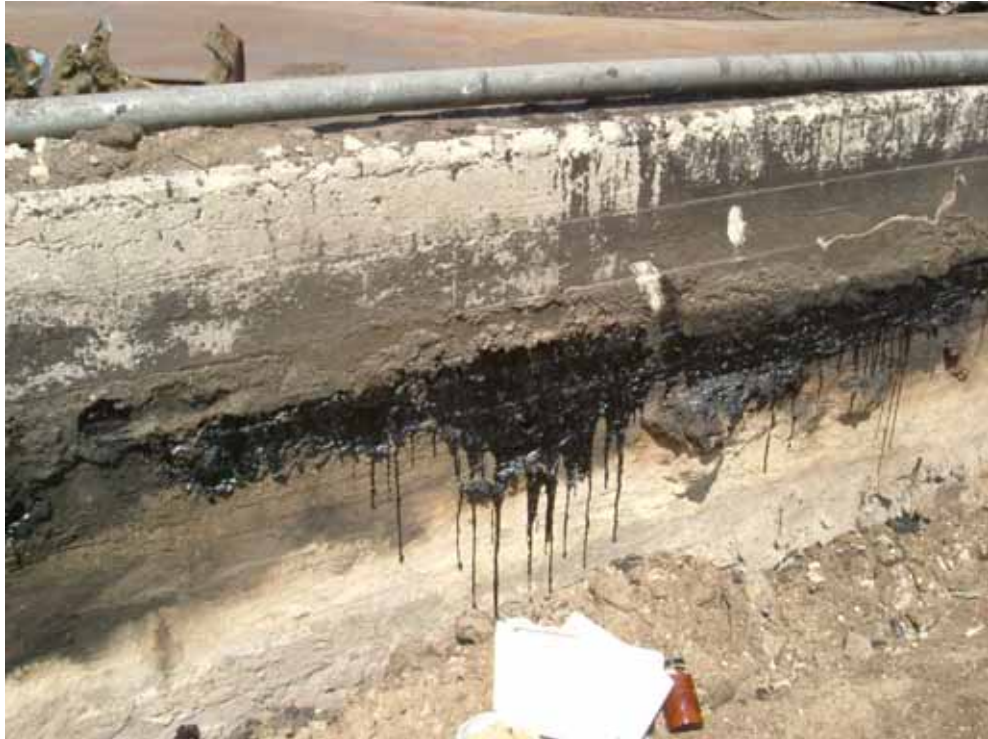
It was also noted during the walkover on 2nd September 2003 that a number of large metal pipes, apparently excavated from the area adjacent to TP49 and had been placed on the northern waste mound. The pipes appeared to contain thick black hydrocarbons which could be seen to be leaking onto the waste mound.

Hydrocarbon Staining adjacent to TP49

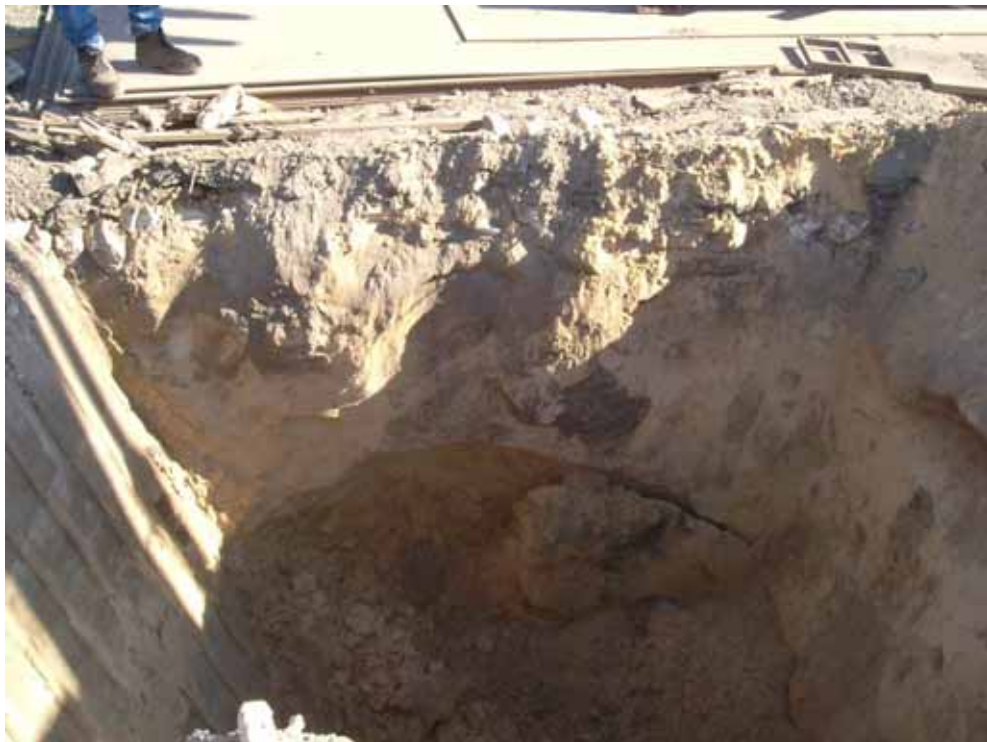
Trial Pit TP50

Remarks Water entry below 1.5m		
	Scale (approx) 1:50	Logged By ML	Figure No. A249-00.TP50
